KEYS CONSULTING LTD

LEVEL 2

# Your survey report ...

Surveyor's RICS number  
0850121

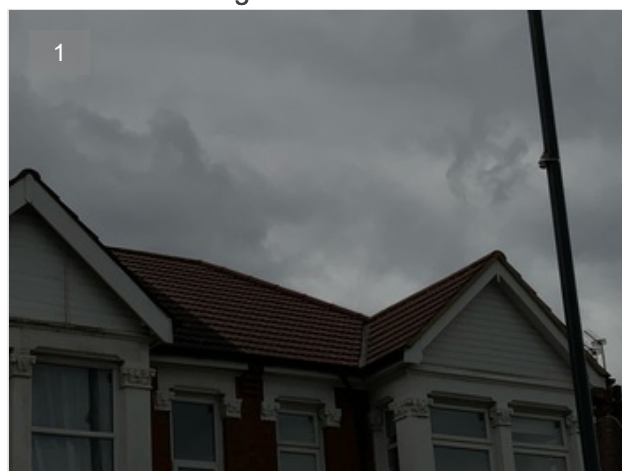
### D2 Roof coverings

The main roof is a conventional hipped style and is covered with tiles. The roof condition is consistent with its age and type. The roof appeared flat, and the covering is recent. No evidence of slipped, broken, or missing tiles was viewed. Condition rating 1. No repair is required. The property must be maintained in the normal way.

A double-storey bay element has been included at the front. The roof is a conventional pitched style and is covered with tiles. There is a sloping valley gutter at the junction of the roofs above the bay section, and this is lined with lead. The valley appeared clear of debris and moss growth. No evidence of slipped, broken or missing tiles was viewed. Condition rating 1. No repair is currently needed. The property must be maintained in the normal way.

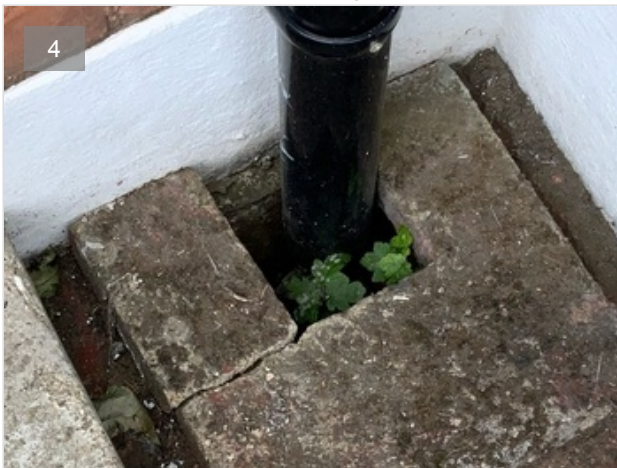
### D3 Rainwater pipes and gutters

Gutters and downpipes are of uPVC material with no evidence of leaking joints or obvious signs of overflowing noted. They appeared intact but it was not raining at the time of inspection. Condition rating 1. No repair is currently needed. The property must be maintained in the normal way.

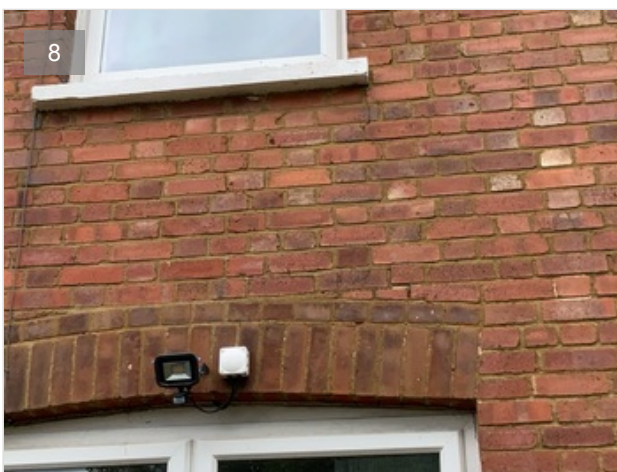
### D4 Main walls

The main walls of the original building are of solid brickwork approximately 225 mm thick which is typical construction for the period. The elevations are finished with facing brickwork. The external parts are in a reasonable condition consistent with their age. No significant structural cracking was noted, although the brickwork around the rear door entrance is poor. Condition rating 1. No repair is currently needed. The property must be maintained in the normal way.

Parts of the brickwork above the patio doors reflect hairline diagonal/stepped cracks. The cracks appear historic and may relate to minor movement. This is not a significant concern. Inside the property will be viewed to determine if the cracks require attention soon. Condition rating 1. No repair is currently needed. The property must be maintained in the normal way.

The damp proof course cannot be seen clearly, however, in properties of this age it is likely to be of slate or similar material. Also, refer to the internal walls and partitions section. Condition rating 1. No repair is currently needed. The property must be maintained in the normal way.

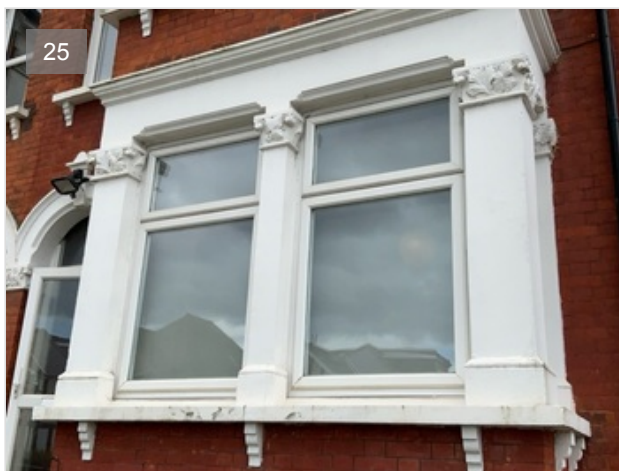
### D5 Windows

The windows are of a replacement, uPVC variety with double glazing which is relatively modern however are tired and begrimed requiring cleaning down and servicing. These appear to be in serviceable condition with no breaking down of the double-glazed units noted. However, it should be appreciated that the quality of uPVC double glazing varies enormously. Condition rating 1. No repair is currently needed. The property must be maintained in the normal way.

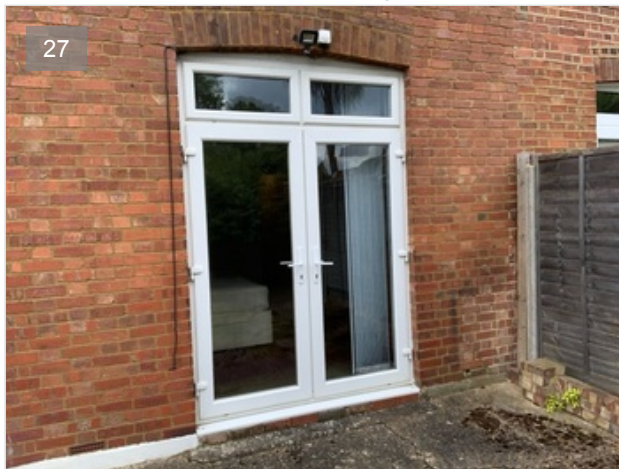
### D6 Outside doors (including patio doors)

The doors are replacement uPVC variety with double glazing. The doors appears fully functional and no excessive difficulties were experienced or defects noted. Condition rating 1. No repair is currently needed. The property must be maintained in the normal way.

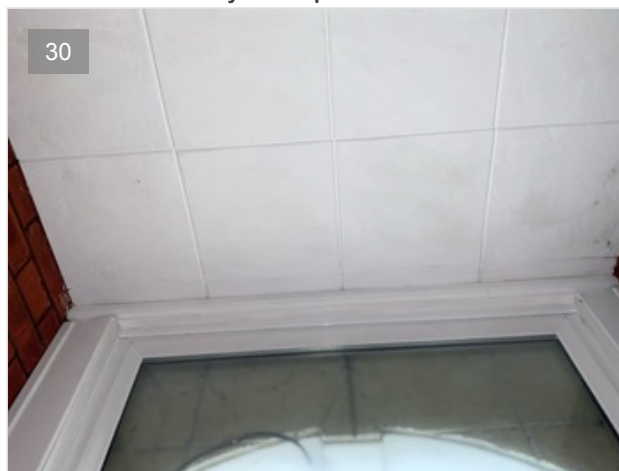
### D7 Conservatory and porches

| Element no. | Element name | Comments (if applicable) |
|---|---|---|
| D7 | Conservatory and porches | The polystyrene tiles in the porch are a safety hazard because they are flammable and give off poisonous fumes in a fire. |

The porch is an integrated arrangement at the entrance. The walls are finished brickwork, the ceiling has been covered with polystyrene, and the floor has been carpeted. No cracking or dampness was evident. Condition rating 1. No repair is currently needed. The property must be maintained in the normal way.

Polystyrene tiles are a safety hazard because they are flammable and give off poisonous fumes in a fire. These should be removed now. This may damage the ceiling underneath requiring more extensive repairs. Condition rating 3. The defect is serious and/or needs to be repaired, replaced or investigated urgently.

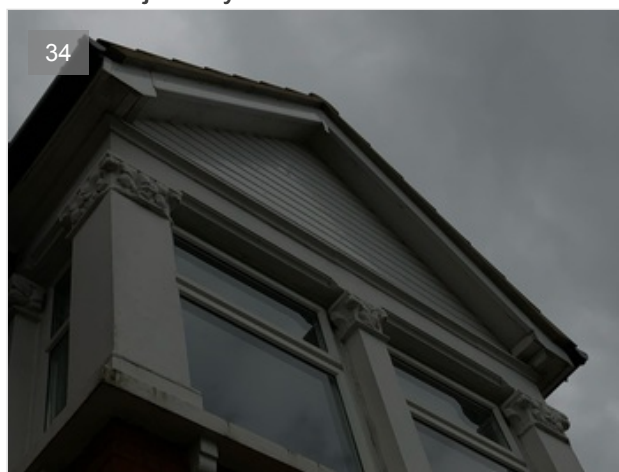
### D8 Other joinery and finishes

The external joinery/finishes include fascia and soffit boarding at the eaves, and these are made of uPVC. The surfaces appear reasonably flat and free from damage. These items are in good condition and should be relatively maintenance-free. Condition rating 1. No repair is currently needed. The property must be maintained in the normal way.

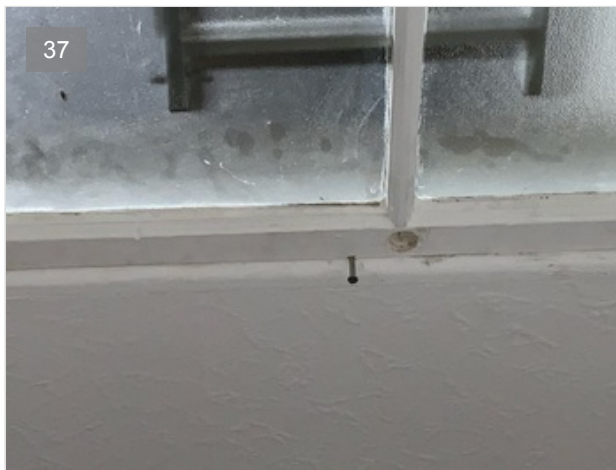
The loft access has been screwed fixed consequently was not inspected.

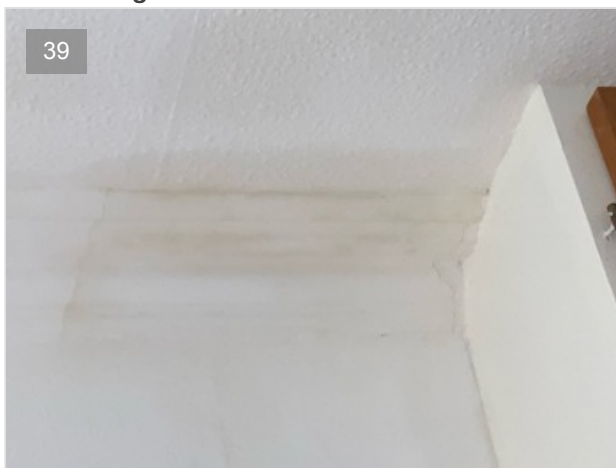
### E2 Ceilings

The ceilings have been covered with a heavy lining textured paper covering. Damp patches were viewed adjacent to the chimney breast at first floor level. Although it's not clear if the chimney stacks have been removed or if the dampness evident is historic. Removing this during redecoration may damage the plaster and you should plan for additional repairs. Condition rating 3. The defect is serious and/or needs to be repaired, replaced or investigated urgently.

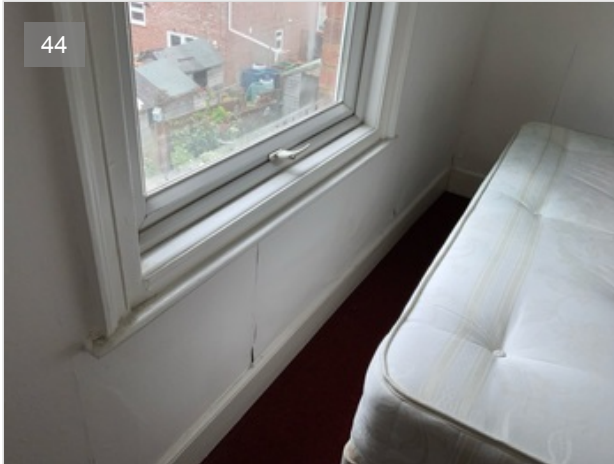
### E3 Walls and partitions

| Element no. | Element name | Comments (if applicable) |
|---|---|---|
| E3 | Walls and partitions | Evidence of dampness was noted that is water ingress adjacent to the chimney breast and condensation generally. |

Internal partition walls are a mixture of solid masonry construction with a plastered finish and timber studwork faced with plasterboard. The wall surfaces are generally vertical with no significant cracks. Although evidence of dampness was viewed adjacent to the chimney breasts as already noted (also refer to the ceilings section). Dampness in the form of condensation was also noted generally primarily within the bedrooms. Condition rating 3. The defect is serious and/or needs to be repaired, replaced or investigated urgently.

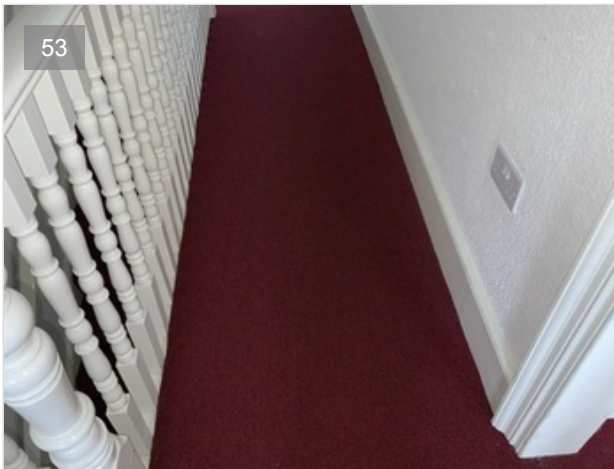
### E4 Floors

The floors are estimated to be timber comprising of joists and boards. A few slightly loose floorboards were detected under the fitted carpet on the grd/1st floor. Condition rating 1. No repairs are required. The property should be maintained in the normal way.

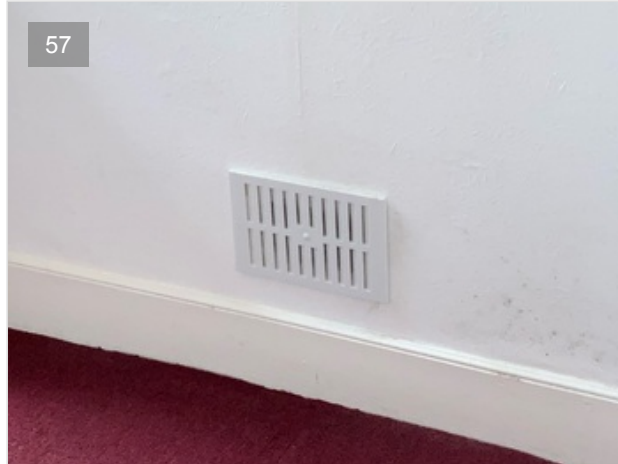
### E5 Fireplaces, chimney breasts and flues

The chimney breast have been closed, but there was no sign of dampness associated with ventilation issues. Although dampness was noted associated with the roof ceiling/walls as stated earlier. Condition rating 1. No repair is currently needed. The property must be maintained in the normal way.

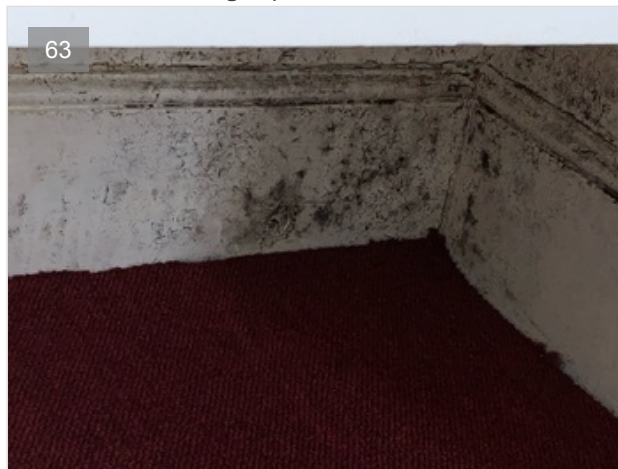
### E6 Built-in fittings (built-in kitchen and other fittings, not including appliances )

The bedrooms have been fitted with built-in wardrobes. The fittings are in a serviceable condition consistent with their age and construction. No excessive evidence of wear or damage was viewed, although condensation was viewed at low level. Condition rating 2. A defect needs repairing or replacement but is not considered to be serious or urgent. The property must be maintained in the normal way.

The kitchen is fitted with built-in fittings that have been reasonably maintained and remain functional. It has been fitted with a modest range of wall cupboards and base units incorporating appliances and worktop surfaces. The units may have been at the height fashion at the time of installation but now appear dated. Condition rating 1. No repair is currently needed. The property must be maintained in the normal way.

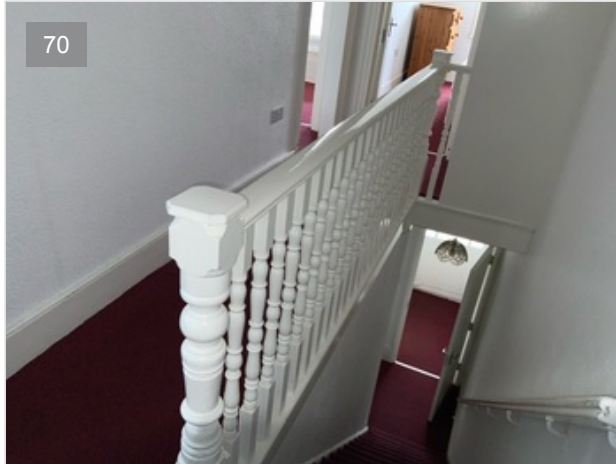
### E7 Woodwork (for example, staircase joinery)

The internal woodwork comprises a mix of original and renewed timbers. These are both finished with a paint finish. Considering the age of the original timbers they remain at a good standard. The woodwork viewed is in a fair condition with only general wear and tear noted. Condition rating 1. No repairs are required. The property should be maintained in the normal way.

The stairs and landing have been covered with a fully fitted carpet and generally felt level and firm underfoot. Various floorboards were noted to creak underfoot.

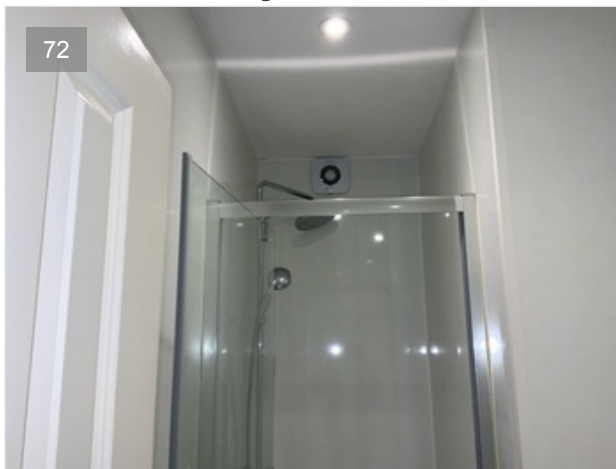
### E8 Bathroom fittings

The fittings in the bathroom/shower room/toilet comprise customary items i.e. bath/shower, toilet and wash-hand basin. They appear to have been installed in recent times. No leaks or damage were viewed. Condition rating 1. No repair is currently needed. The property must be maintained in the normal way.

Wall panels have been installed to the walls with no opening up of joints or damage noted. Condition rating 1. No repair is currently needed. The property must be maintained in the normal way.

Ceramic tiles have been installed to the floors with no opening up of grouted joints or splitting of tiles noted. Condition rating 1. No repair is currently needed. The property must be maintained in the normal way.

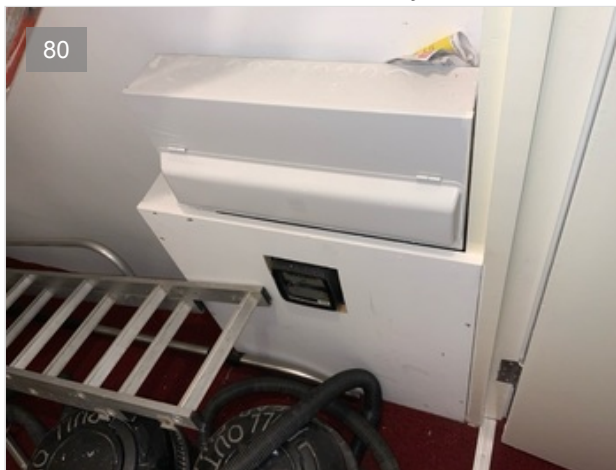
### F1 Electricity

The property has a mains electricity supply. The electricity meter is located within an internal enclosure with the consumer unit. The supply is 60A/100A and a standard meter is installed. I saw no evidence that this electrical system has recently been inspected in the form of a test certificate. Condition rating 3. You should ask your legal adviser to request evidence of test certification.

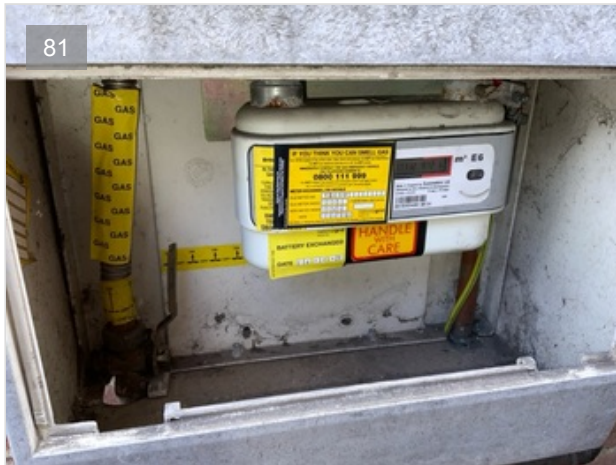
### F2 Gas/oil

There is a private gas supply connected to the property. The control valve and meter are located in an external enclosure. The meter is the new arrangement. All gas installations need to be inspected every 12 months and I have seen no evidence that this has been done by a Gas Safe registered engineer. You should ask your legal adviser to request evidence of testing that has been carried out. Although visually there is no evidence of damage to visible pipework, it is important to establish that the installation does not pose a safety risk. Condition rating 3. You should ask your legal adviser to request evidence of test certification.

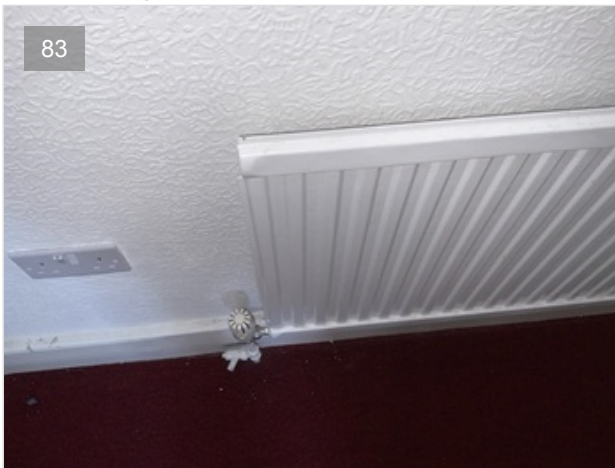
### F4 Heating

A gas-fired boiler is located in the bathroom and provides hot water and central heating via radiators. The central heating system was not in operation at the time of inspection. A Gas Safe or OFTEC registered engineer should leave appropriate documentation with the homeowner that identifies the type and extent of the work done. This should include all heating systems and appliances, for example, boilers, individual room heaters, all open fires, etc. I have not seen evidence that this has been done. Condition rating 3. Heating systems and appliances that have not been checked may be a safety hazard. You should ask your legal adviser to request evidence of test certification.

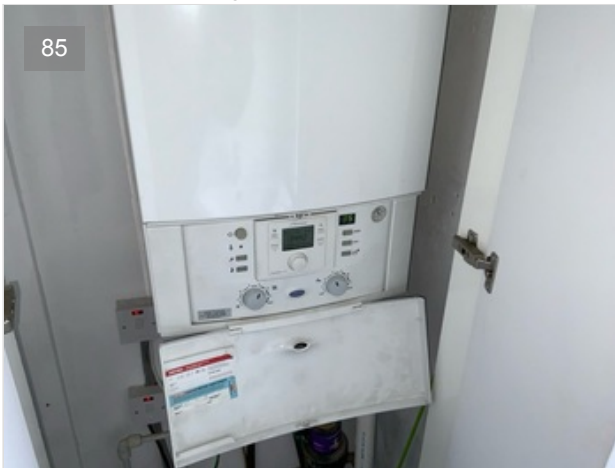
### F5 Water heating

The gas-fired boiler provides hot water to the taps and central heating system. The hot water provided by the boiler is instantaneous, and there is no hot storage tank. The absence of a hot water storage tank will produce a higher running cost. I did not see evidence that the appliance had been recently serviced in the last 12 months. Condition rating 3. The defect is serious and/or needs to be repaired, replaced or investigated urgently. You should ask your legal adviser to request evidence of test certification.

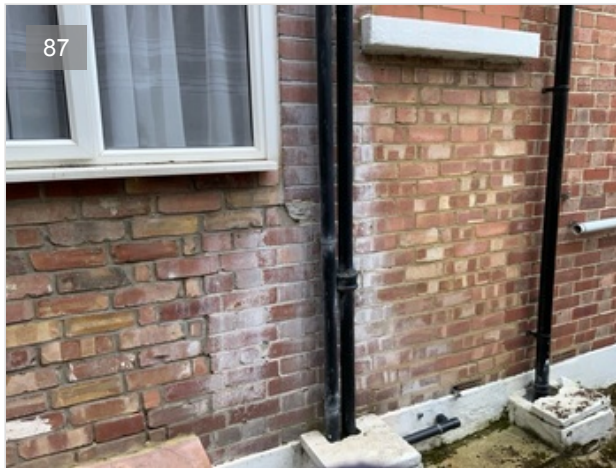
### F6 Drainage

Mains drainage is connected. Wastes from the bathroom sanitary fittings are largely concealed within the building. Plastic waste pipework serving the bathroom/kitchen sink and other appliances discharge into an open gully at the rear/side. The drainage in this area is in need of attention as the waste water is discharging onto the walls. There is a single of metal drainage inspection chamber at the rear/side. The inspection drain cover is damaged and it may not have been possible to reinstate if removed. Although there was no evidence of foul waste backing up or discharging issues. The soil stack is made of plastic/cast iron. It is positioned at the rear/side and is remote from window openings. The soil and vent pipe has no evidence of leaking joints. Condition rating 1. No repair is required. The property should be maintained in the normal way.

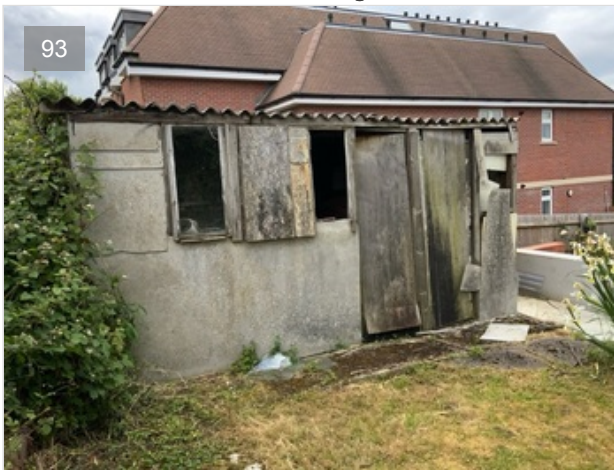
### G2 Permanent outbuildings and other structures

| Element no. | Element name | Comments (if applicable) |
|---|--|---|
| G2 | Permanent outbuildings and other structures | The outbuilding appear poor condition and it would be more economical to demolish and rebuild opposed to considering repairs. |

The outbuilding(s) comprising a timber/sheeting structures located at the rear. The roof is finished with corrugated roofing sheeting. The buildings appear poor condition and it would be more economical to demolish and rebuild opposed to considering repairs. Condition rating 2. A defect needs repairing or replacement but is not considered to be

The roof covering may contain small amounts of asbestos fibres and if disturbed, it could be a safety hazard. If the roof needs repairing, you will have to use a contractor experienced in this type of work or an asbestos specialist.

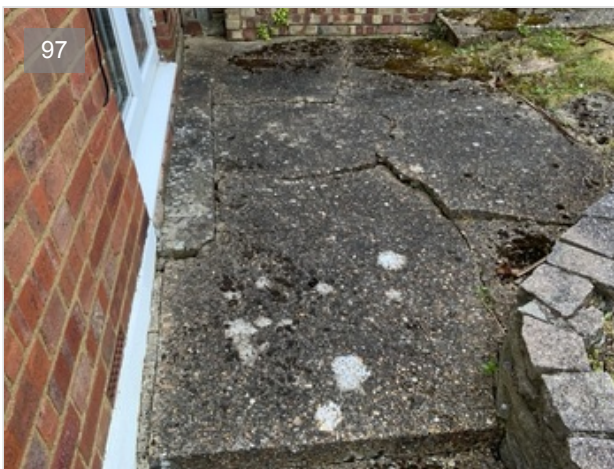
### G3 Other

The property occupies grounds to the front and rear. The front has a shallow rectangular shape, is finished with lawn/paving, and provides a garden area. The boundaries are clearly defined and made of brick/timber, most of which is in reasonable condition. Condition 1. No repair is currently required. The property must be maintained in the normal way.

The rear garden is a deep rectangular shape. This comprises a lawn with a paved patio. The boundaries are clearly defined principally of timber/plastic wiring fencing, most of which is in reasonably good condition. The perimeter is populated with a range of plants, shrubs and trees that appear to be maintained. None of the plants viewed seemed to be the significant invasive type. Condition 1. No repair is currently required. The property must be maintained in the normal way.

The footpath/patio is made of concrete slabs. It's in poor condition comprising a number of undulations/uneven and major cracks. In several areas significant trip hazards have been created. Although they were stable underfoot at the time of inspection. Condition rating 2. A defect needs repairing or replacement but is not considered to be serious or urgent. The property must be maintained in the normal way.

The garden of the property contains a number of large trees that are close to the house. The property is built on soil that can become unstable when affected by tree roots. The resulting impact could be subsidence or damaged drainage. Although no impact of the trees was viewed at the time of inspection.
