KEYS CONSULTING LTD

# Your survey report

Inspection date  
24/08/2023

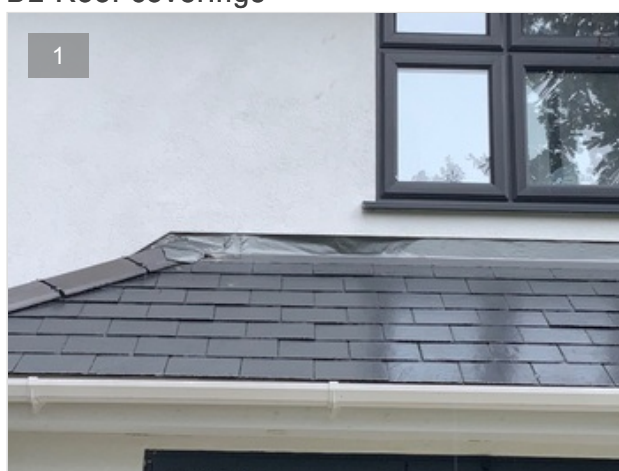
### D2 Roof coverings

The main roofs are conventional pitched/hipped modified style and are covered with tiles. It is normal for properties of this age and type not to have roofing felt. Without this, water may get into the roof space, especially during windy weather. Also, refer to inside the property roof structure for more details. The ridge-line is straight and the roof surface is reasonably flat. The bedding mortar to the ridge tiles appears in reasonable condition with the tiles firmly bedded into position. The roof covering is in a serviceable condition with no significant slippage or deterioration of the tiles noted. Condition rating 1. No repair is required. The property must be maintained in the normal way.

The verge pointing at the left and right-hand gable is in good condition with no significant areas of missing mortar noted. The verge condition is consistent with its age and type. The tile under the cloak has been formed in slate/fibrous board with no significant damage noted. Condition rating 1. No repair is required. The property must be maintained in the normal way.

The right-hand roof has a flat top roof estimated to be an Ethylene Propylene Diene Monomer (EPDM), it also includes double glazed skylight(s). It appears to be intact maintaining a waterproof seal, however, at the time of the inspection. No external cracks or scratches damage was viewed from the ground. Condition rating 1. No repair is currently needed. The property must be maintained in the normal way.

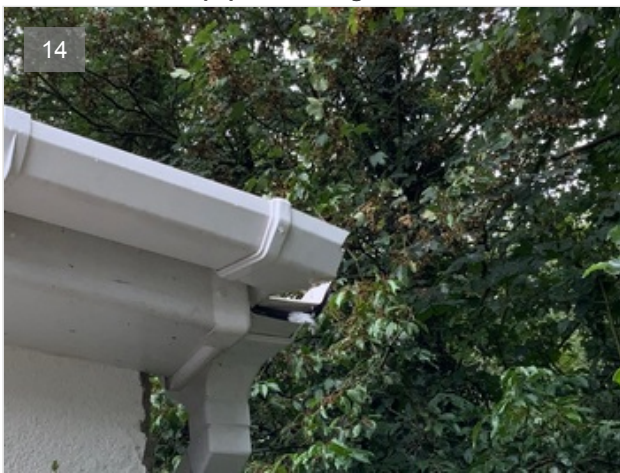
### D3 Rainwater pipes and gutters

<p>24/08/2023 09:20 (BST)</p>	<p>The gutters and downpipes are made of uPVC material. This material tends to be dent and corrosion-resistant but can become brittle with age. It was not raining at the time of the inspection, consequently, it was not possible to confirm if the gutter joints were completely watertight. However, there was no significant staining on the walls adjacent to the downpipes or staining around the joints to suggest that there were leaks. Gutters and downpipes carry many hundreds of litres of water during wet weather. Their joints and stop ends are particularly prone to failure as are the outfalls which can be easily blocked by leaves and other debris. All rainwater fittings should be periodically inspected and kept clear of blockage as leakage/overflow can cause damage to the external fabric and may result in damp problems. Condition rating 1. No repair is currently needed. The property must be maintained in the normal way.</p> <p>The garage gutters at the right hand are due to the absence of a corner piece. Condition rating 2, You should repair this soon. The defect needs repairing or replacement but is not considered to be serious or urgent. The property must be maintained in the normal way.</p>

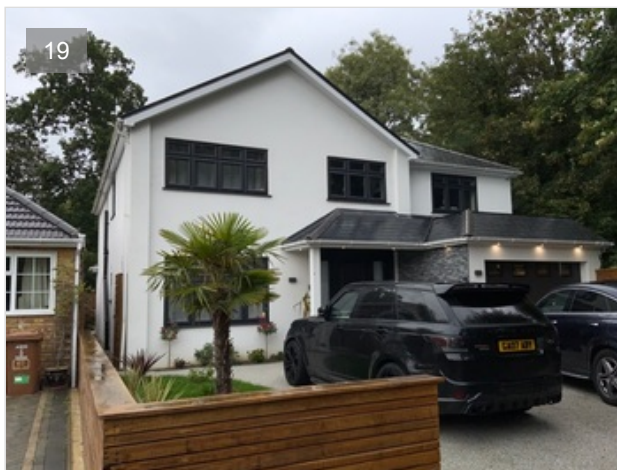
### D4 Main walls

The main building is of cavity construction (two masonry skins with a gap between) approximately 275 mm thick with render finish. Cavity walls are superior to traditional solid wall construction in that they have a higher insulation value giving rise to comparatively lower heat loss. Cavity walls are also less prone to penetrating dampness due to the gap in the cavity arrangement. The render does not appear to have any significant structural cracking or deformations noted. It's in good condition consistent with its age and generally well pointed. Condition rating 1. No repair is currently needed. The property must be maintained in the normal way.

The damp proof course (DPC) cannot be seen, however in properties of this age, it is likely to be of uPVC. This product does not experience fracture damage as the traditional slate DPC. Condition rating 1. No repair is currently needed. The property must be maintained in the normal

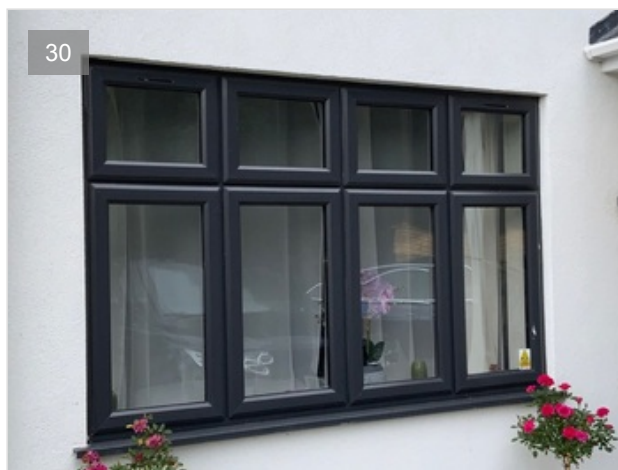
### D5 Windows

The windows are of a replacement, uPVC variety with double glazing. Replacement windows provided improved energy performance, safety, and ventilation. Further, in the long term, uPVC windows can suffer from discolouring and brittleness due to UV rays. The windows viewed appeared in good condition. However, it should be appreciated that the quality of double glazing varies enormously and failure of the double glazing commonly occurs after a number of years this deterioration can result in condensation forming between the double-glazed panes. If this happens they should be replaced, their life is generally 15 to 20 years. Condensation within failed units may come and go depending on the temperature and the weather. Further, the quality of the seals around the edges of the glass can vary in quality particularly. Eventually, these seals tend to deteriorate resulting in misting and the need for repair or replacement. Although no signs of failure were viewed at the time of our visit. Condition rating 1. No repair is currently needed. The property must be maintained in the normal way.

Although the utility room has got metal double glazed units. The windows appear in reasonable condition and function satisfactorily. Condition rating 1. No repair is currently needed. The property must be maintained in the normal way.

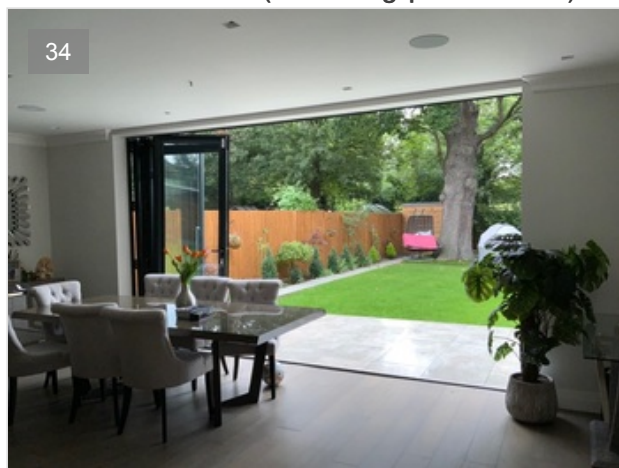
### D6 Outside doors (including patio doors)

Doors are openable barriers at the entrance to buildings. The front door is a replacement timber variety. It swings on hinges and includes furniture or ironmongery that allows them to open, close, latch, and lock all of which appeared acceptable. Draft seals are commonly installed to reduce heat loss and were present. The door is incorporated within a timber frame that includes a metal weather in the sill. The door and frame viewed is to a good serviceable standard. Condition rating 1. No repair is currently needed. The property must be maintained in the normal way.

At the rear elevation, bi-fold replacement metal doors are installed incorporating double glazed units. These types of doors can stick if the track is not level or free of debris. The doors viewed are heavy and difficulties were experienced opening or closing the doors, albeit not excessive. Condition rating 1. No repair is currently needed. The property must be maintained in the normal way.

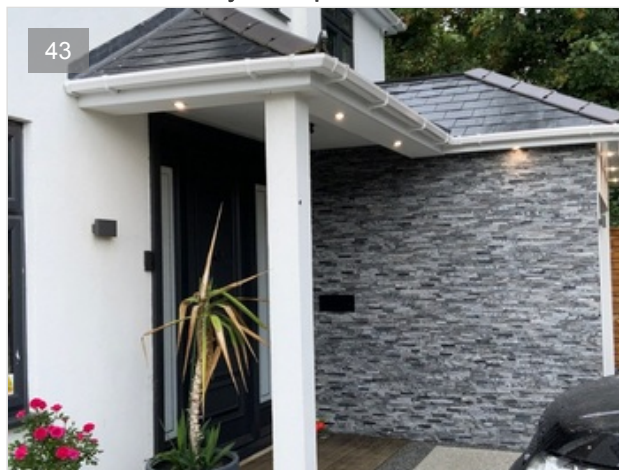
### D7 Conservatory and porches

The porch is in a canopy arrangement and the roof is hipped and covered with tiles. The framing is made of timber in a suspended arrangement. There is a plastic gutter to disperse rainfall, although the downpipe is remote. It appears to be in a good condition with no evidence of rot or decay. Condition rating 1. No repair is currently needed. The property must be maintained in the normal way.

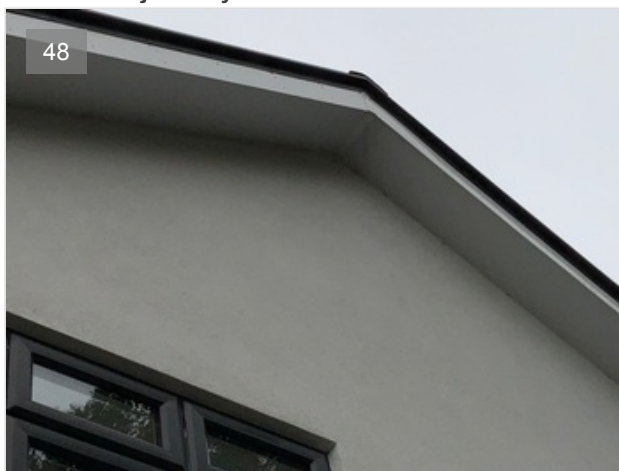
### D8 Other joinery and finishes

The external joinery/finishes made of uPVC appear reasonably flat and free from damage. These items are in good condition and should be relatively maintenance-free. Condition rating 1. No repair is currently needed. The property must be maintained in the normal way.

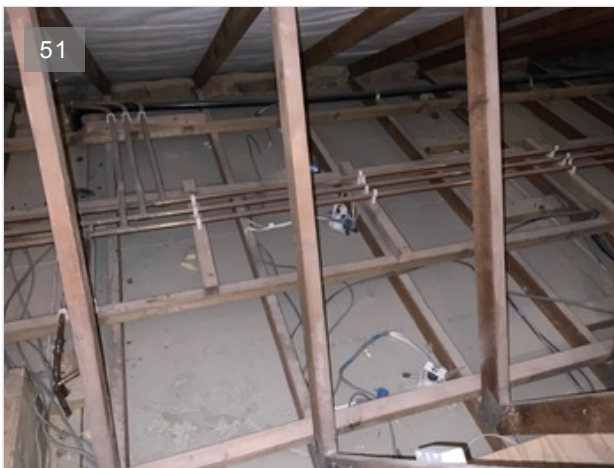
### E1 Roof structure

Access to the roof space is via a hatch in the hallway. The roof is of a conventional timber frame comprising rafters, purlins, and ceiling joists. The roof timbers appear to be of adequate dimensions and are without significant distortion. The roof slopes are lined with roofing felt and this will add a second level of waterproofing in the event that any tiles slip or the wind lifts them. No significant rips or tears were noted in the felt. Between the ceiling, joists have not been insulated. This will result in lower internal temperatures and higher heating costs through the main roof. Condition rating 2. A defect needs repairing or replacement but is not considered to be serious or urgent. The property must be maintained in the normal way.

No dampness or water ingress was viewed. Condition rating 1. No repair is currently needed. The property must be maintained in the normal way.

No significant build-up of condensation within the roof void was noted to suggest that ventilation is not adequate. Condition rating 1. No repair is currently needed. The property must be maintained in the normal way.

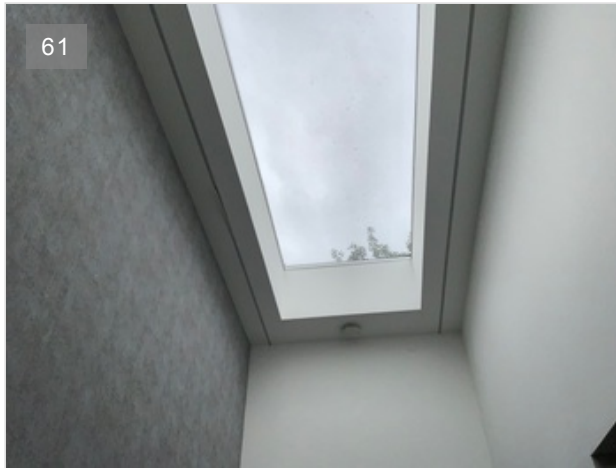
### E2 Ceilings

The ceilings are plasterboard as part of the extension/refurbishment works. Ceiling surfaces have a smooth skim plaster finish and emulsion paint finish and are generally level and without serious defects. Ceilings of plasterboard can crack at the joints between the boards if not tapped/jointed and small areas of plaster can be dislodged by the nail fixings. Hairline cracks were noted in the following locations,

- Rear right-hand bedroom the wall and ceiling adjacent to the ensuite,
- Rear left-hand bedroom crack above the right hand of the window
- Front right-hand bedroom perpendicular crack above the entrance. Also watermarks evidence

The ceiling within the front right-hand bedroom reflects watermarks around the entrance. This appears to be adjacent to the heating systems in the roof space suggesting there has been a leak in the past. Condition rating 1. No repair is currently needed. The property must be maintained in the normal way.

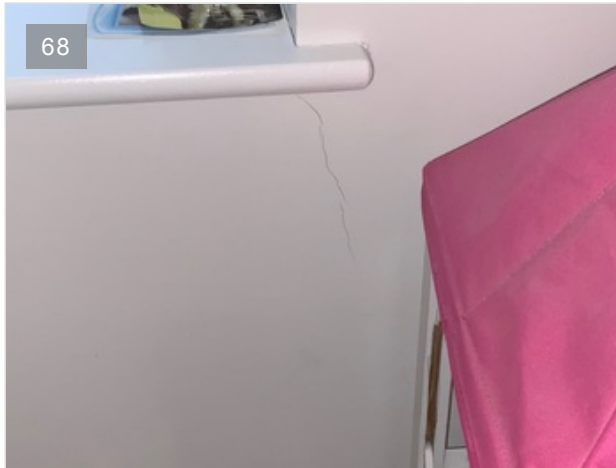
### E3 Walls and partitions

Internal partition walls are a mixture of solid masonry construction with a plastered finish and timber studwork faced with plasterboard finished with a plaster skim coat. The utility room's external walls are made of stud work and run along the perimeter of the boundary. The wall surfaces are generally vertical with no significant cracking or dampness noted and conditions are reasonable. Hairline cracks were noted in the following locations,

- Rear right-hand bedroom has a small diagonal crack beneath the right hand corner of the window
- Rear right hand bedroom horizontal cracking adjacent to the ensuite at the junction of the wall and ceiling
- Front right hand bedroom vertical crack to the right hand of the window
- First floor hallway, various cracks around the area of the staircase landing

The original partition walls have been removed on the ground floor to create a through the lounge/dining room. It is assumed that adequate support has been provided in the form of a steel beam to carry the weight of the first floor however your legal adviser will need to confirm that the necessary local authority consents were obtained for this alteration. Although no cracks or excessive deflection was viewed to suggest there were any issues.

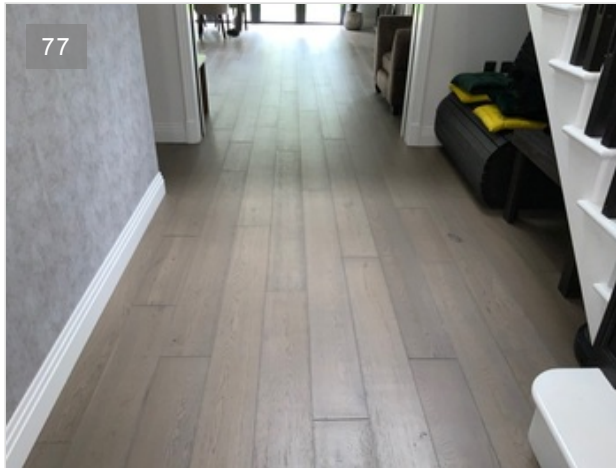
### E4 Floors

The floors are a combination of solid and timber construction (their actual formation is not known). The solid is on the ground floor and timber is on the 1st floor.

The solid floors are assumed to include a barrier against dampness from the ground (called a damp-proof membrane or DPM), in accordance with current standards. The absence of this provision will make the floor vulnerable to dampness. The presence of fitted coverings prevented moisture meter tests. Although no dampness was viewed to imply that there is a problem. The ground floor has been covered with laminated boards, which cover a large unobstructed area, however, the floor felt level and firm underfoot. Condition rating 1. No repairs are required. The property should be maintained in the normal way.

The timber floor(s) comprising of joists and boards. A few slightly loose floorboards were detected under the fitted carpet on the 1st floor. It may be necessary to lift the carpet in places and re-secure boards to the joists beneath. The boards can either be secured with serrated nails or screws when the carpet finishes are next pulled back. Condition rating 1. No repairs are required. The property should be maintained in the normal way.

The stairs and landing have been covered with a fully fitted carpet and generally felt level and firm underfoot. Various floorboards were noted to creak underfoot which we would advise are secured down with either serrated nails or screws when the carpet finishes are next pulled back. Condition rating 1. No repair is currently needed. The property must be maintained in the normal way.

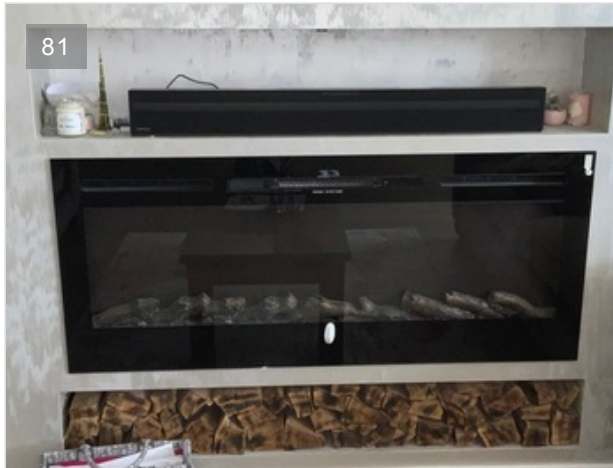
### E5 Fireplaces, chimney breasts and flues

An electronic fire is located living room. The electric fireplace doesn't use air from the room for combustion, therefore, there is no need for open vents as required by the Building Regulations for gas fires. Condition rating 1. No repair is currently needed. The property must be maintained in the normal way.

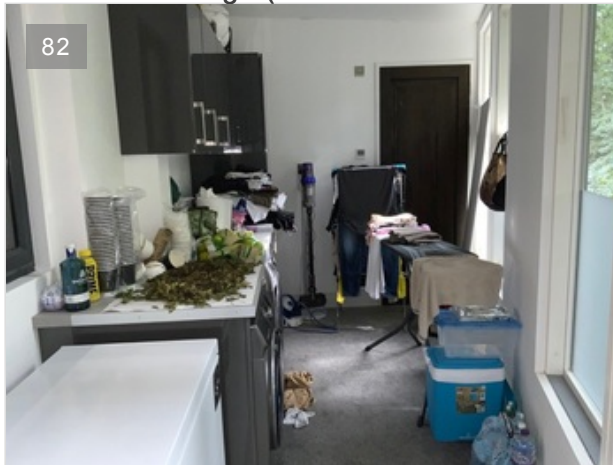
### E6 Built-in fittings (built-in kitchen and other fittings, not including appliances )

The bedrooms have been fitted with built-in wardrobes; these have a combination of shelves, drawers, and hanging rails, some doors being mirrors and dressing units are provided in some areas. The installations appear to be modern and comprise of laminate finish. The fittings have been maintained to a high standard and will add to the value of the property. Condition rating 1. No repair is currently needed. The property must be maintained in the normal way.

The kitchen is fitted with a higher than the usual number of built-in fittings that will add to the attractions of the property. It has been refitted in recent years with a range of quality wall cupboards and base units incorporating modern appliances and worktop surfaces. The units and cupboards are fitted with drawers and shelves. The doors/drawers are fitted with soft closers to mitigate load impact noise or damage when closing. Condition rating 1. No repair is currently needed. The property must be maintained in the normal way

Adjacent to the kitchen is comprised of a utility room, consisting of appliances. The room does include an extract fan to remove moisture vapour build up. Condition rating 2. A defect needs repairing or replacement but is not considered to be serious or urgent. The property must be maintained in the normal way.

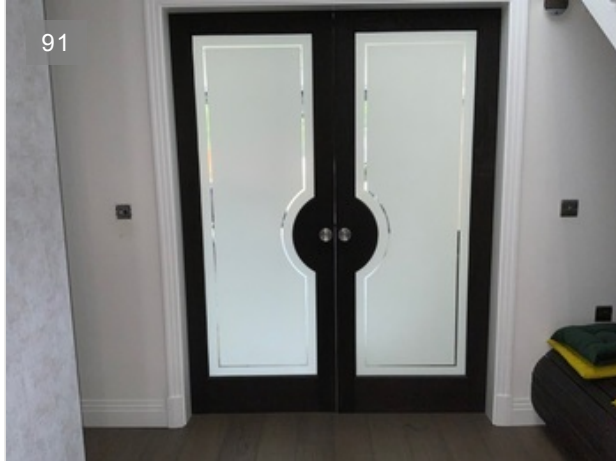
### E7 Woodwork (for example, staircase joinery)

The internal woodwork has been largely renewed in recent years. New internal doors, skirting, architrave, and window boards have been installed. The woodwork viewed is in a fair condition with only general wear and tear noted. Condition rating 1. No repairs are required. The property should be maintained in the normal way.

The internal doors are made of timber comprising of side, hung fixings, and ironmongery. The ground floor living room door is the only exception and comprises double opening timber framed doors incorporating glazing and installed in a pocket arrangement (i.e. concealed doors). Low-level glazing should be kitemarked to BS6262 Part 4 1994, it is glazing below 1500mm in doors and adjacent glass for a width of 300mm, all dimensions are taken from floor level. This condition should be re-glazed using laminated or toughened glass, or as a minimum, an adhesive safety film is fixed to the panes for added safety. Condition rating 3. The defect is serious and/or needs to be repaired, replaced or investigated urgently.

The doors to the first floor right-hand reflect a very small degree of movement. This could be simply poor fitting or evidence of minor settlement but is not evidence of progressive movement at this stage. Condition rating 2. A defect needs repairing or replacement but is not considered to be serious or urgent. The property must be maintained in the normal way.

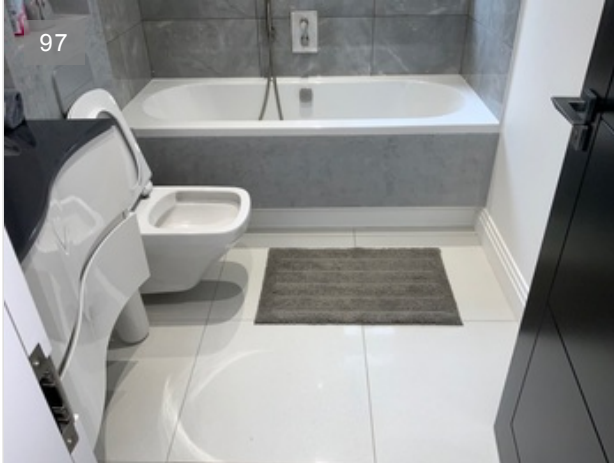
### E8 Bathroom fittings

The fittings in the bathroom/shower room/toilet comprise customary items i.e. bath\ shower, toilet, and wash hand basin. They appear to have been installed in recent times. No leaks or damage were viewed. All areas comprise mechanical ventilation to extract moisture and smells, including run-on functions. The latter ensures that the extract system automatically keeps running after the lights are switched off. Condition rating 1. No repair is currently needed. The property must be maintained in the normal way.

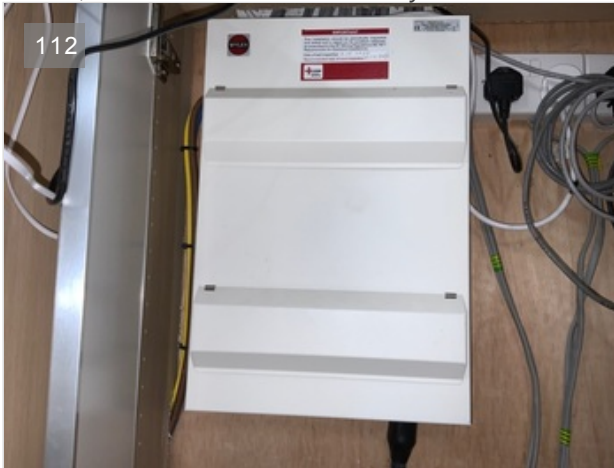
### F1 Electricity

The property has a mains electricity supply. The electricity meter is located within an internal enclosure, together with the consumer unit. The supply is 100A and a smart meter is installed. The visible wiring appears of the modern type. The electrical installation appears satisfactory with no obvious visual defects but much is hidden from view. I have seen evidence that the electrical system was inspected by a qualified electrician on 08/10/2020 and a NICEIC test certificate has been issued. Condition rating 1. No repair is currently needed. The property must be maintained in the normal way.

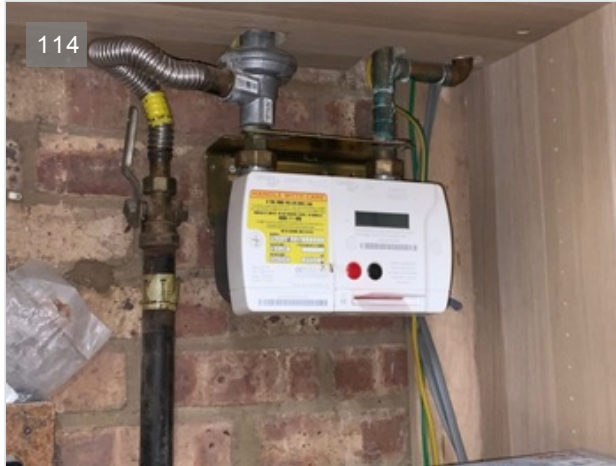
There is a private gas supply connected to the property. Gas is supplied to a given property via the mains gas supply. A supply pipe is run from the main supply pipe up to the property where it is then connected to the meter. The control valve and meter are located in an internal enclosure. The recording system is the newer-style metric meter arrangement. All gas installations need to be inspected every 12 months and I have not seen evidence that this has been done by a Gas Safe registered engineer. An inspection was carried out in 01/10/2020 and the certificate has been viewed. However, you may wish to arrange another inspection. Although visually there is no evidence of damage to visible pipework or connections the last engineer's inspection was not recent and appears to only relate to the boiler installation. Condition rating 3. The defect is serious and/or needs to be repaired, replaced, or investigated urgently.

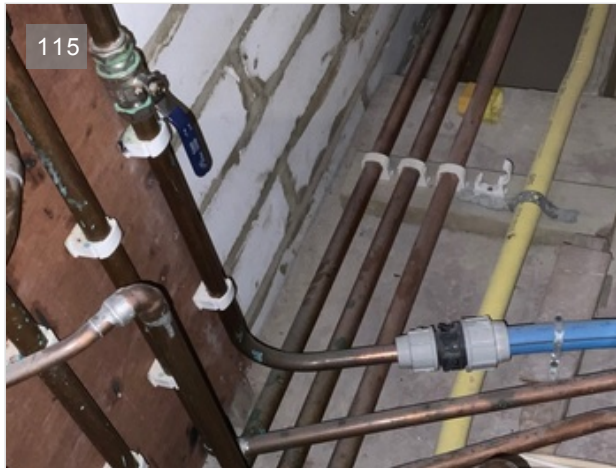
### F3 Water

The property has a cold water direct system. A mains water supply is connected and it distributes water all over the house at mains pressure. The incoming water main route is covered and could not be determined. Visible water pipework is of the modern variety. There is no water storage tank in this system. It is fed directly from the rising main which can be inconvenient if the supply is disturbed. However, this situation is now common as direct feedwater systems are installed. A distinct drop in pressure may be experienced when more than one fitting is turned on at the same time. The stopcock was viewed within the roof void. This is the mains water tap off switch and the original lead mains pipe has been replaced with the blue plastic pipe. You should note the stopcock location, especially during winter when pipes can burst due to frost. Also, the location is not ideal in the event of an emergency because it cannot be accessed swiftly. Condition rating 1. No repair is currently needed. The property must be maintained in the normal way.

is 10 metres/head (or one bar) and their blue pipe should be in the region of 22 mm. This should provide reasonable pressure in the property if similar 22 mm pipes are installed throughout. Random manual water pressure tests indicated that reasonable water pressure is provided at the ground and first floors. Condition rating 1. No repair is currently needed. The property must be maintained in the normal way.

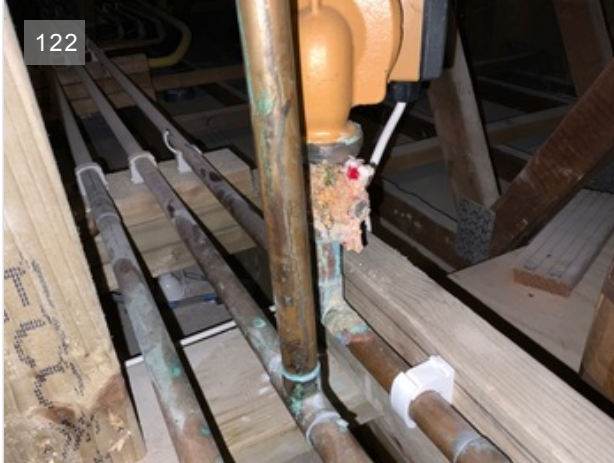
### F5 Water heating

The gas-fired boiler provides hot water to the taps and central heating system. The hot water provided by the boiler is instantaneous and a hot storage cylinder is located in the roof space. The hot water is stored in an unvented hot water storage cylinder. These are mains fed hot water tanks with an inner coil but no open vent pipe. Instead, an expansion vessel allows heated water to expand. Unvented hot water cylinders are steel in order to withstand the increased pressure placed upon them. The cylinder will make the heating system more efficient by reducing running costs. This allows for plenty of hot water without the need for constantly running heating, allowing customers to save money on energy bills.

Distribution pipes and fittings are in copper. Corrosion can occur in pipework as a result of electrolytic action, It's recommended the installation is protected by corrosion inhibitors.

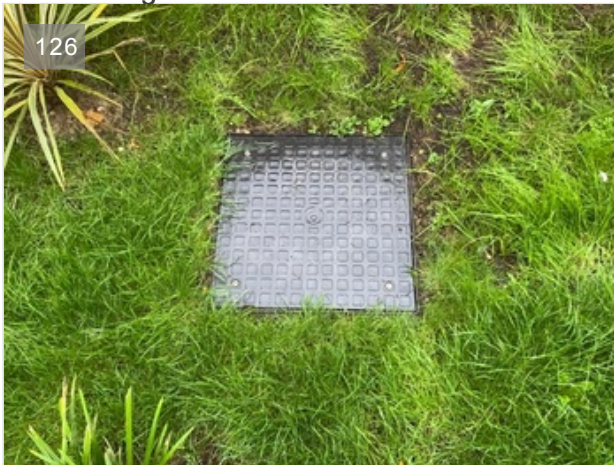
### F6 Drainage

The property is connected to the public sewer and the drainage system could not be determined because they are largely concealed within the building or below ground. In older properties, both foul and surface water go into the same pipes while newer properties keep the two in separate pipes. The drainage system would consist of a separate drain for both surface water (for example rainwater, water from yard drains) and foul water (wastewater from WCs, baths, showers sinks, basins, and dishwashers). Condition rating 1. No repair is currently needed. The property must be maintained

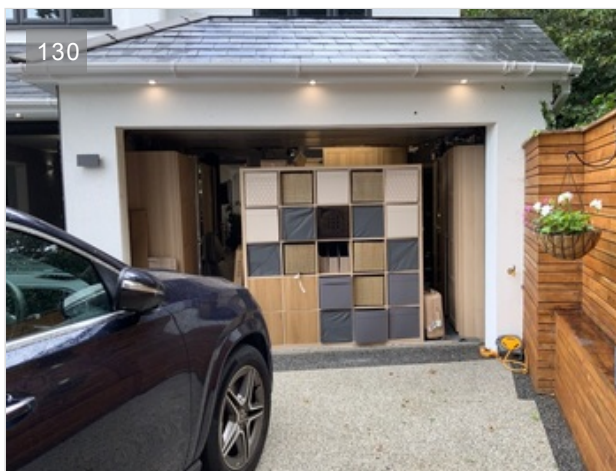
### G1 Garage

The garage is positioned to the right and is integrated into the main building. It is constructed of brickwork and includes a flat. The walls have been constructed in a mixture of brick and block with no significant structural cracking noted. The door is a metal lift over variety and was demonstrated to be fully operational.
