KEYS CONSULTING LTD

LEVEL 2

# Your survey report ...

Surveyor's RICS number  
0850121

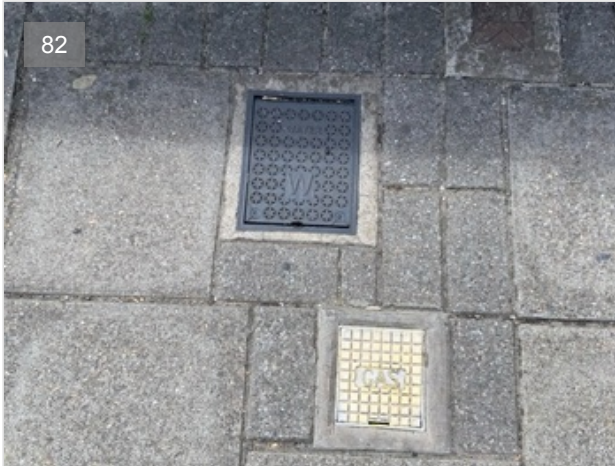
### F3 Water

A gas-fired boiler is located in the bathroom and provides hot water and central heating via radiators. The central heating system was not in operation at the time of inspection. A Gas Safe or OFTEC registered engineer should leave appropriate documentation with the homeowner that identifies the type and extent of the work done. This should include all heating systems and appliances, for example, boilers, individual room heaters, all open fires, etc. I have not seen evidence that this has been done. Condition rating 3. Heating systems and appliances that have not been checked may be a safety hazard. You should ask your legal adviser to request evidence of test certification.

The gas-fired boiler provides hot water to the taps and central heating system. The hot water provided by the boiler is instantaneous, and there is no hot storage tank. The absence of a hot water storage tank will produce a higher running cost. I did not see evidence that the appliance had been recently serviced in the last 12 months. Condition rating 3. The defect is serious and/or needs to be repaired, replaced or investigated urgently. You should ask your legal adviser to request evidence of test certification.
