KEYS CONSULTING LTD

# Your survey report

Inspection date  
24/08/2023

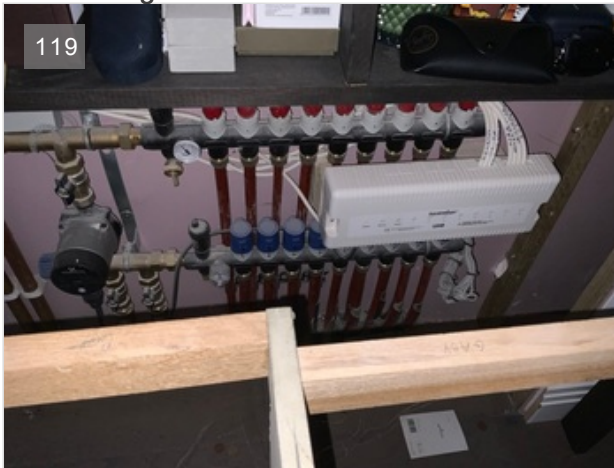
#### F4 Heating

Distribution pipes and fittings are in copper. Corrosion can occur in pipework as a result of electrolytic action, It's recommended the installation is protected by corrosion inhibitors.

Components, connected to the storage cylinder, reflect a build up of carbon deposits, indicating that no maintenance has been carried out recently. I did not see evidence that the appliance had been recently serviced in the last 12 months. Condition rating 3. The defect is serious and/or needs to be repaired, replaced, or investigated urgently. You should ask your legal adviser to request evidence of test certification.

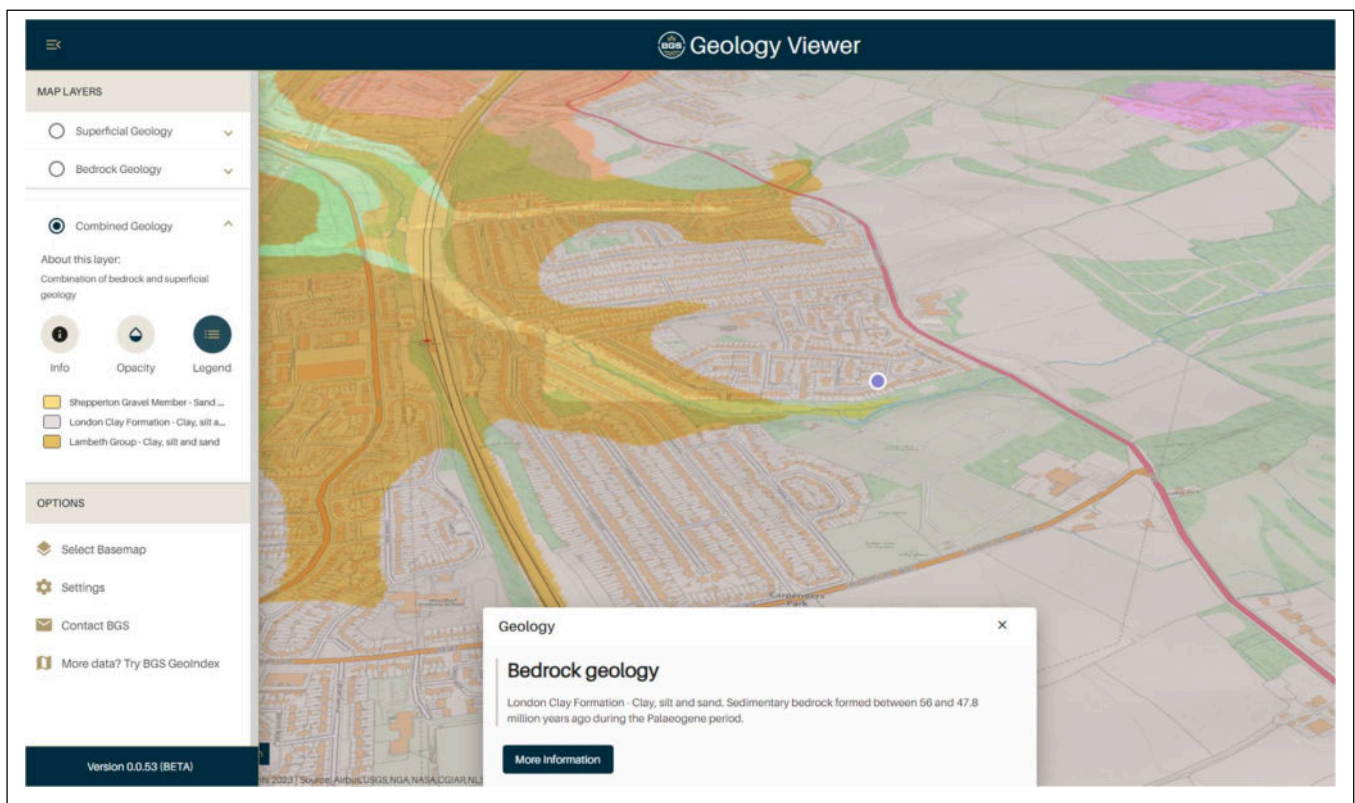
# Attachment 1 – Geology Map

The British Geological Survey map indicates that the postcode region WD19 5BH is based on clay, silt and sand geology. Clay and silt are 'cohesive' soils, meaning the volume varies depending on the moisture content – these soils expand when moist or wet, and shrink when dry. Properties built on clay are particularly at risk of being affected by subsidence in long, dry summers as trees and shrubs suck moisture from the soil, which results in buildings starting to move laterally on their foundations. This is a result, of the clay soil bearing capacity being low in dry conditions.

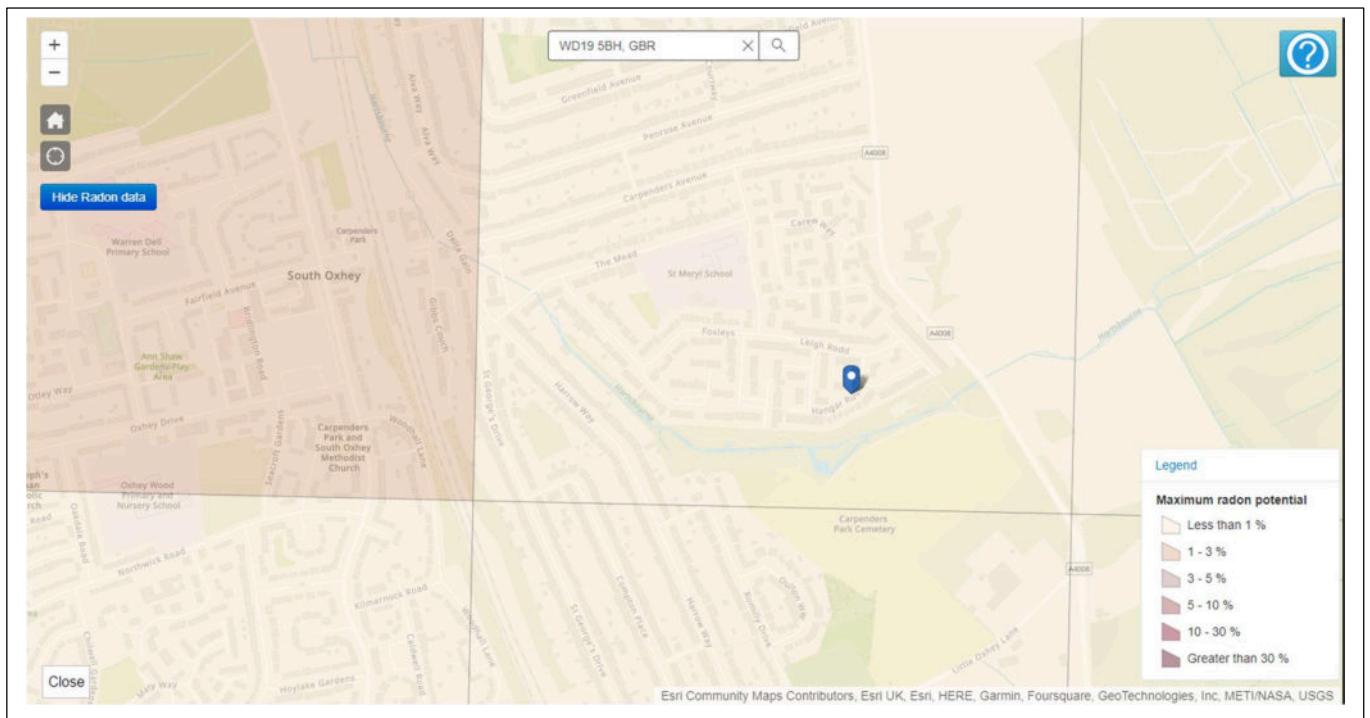
## Attachment 2 – Radon Map

Radon is a radioactive natural gas, which enters buildings from the ground. Exposure to high concentrations increases the risk of lung cancer. Public Health England (PHE) recommends that radon levels should be reduced in properties where the annual average is at or above 200 becquerels per cubic metre (200 Bq m<sup>-3</sup>). This level is termed the Action Level. Public Health England defines radon Affected Areas as those with a 1% chance or more of a house having a radon concentration at or above the Action Level of 200 Bq m<sup>-3</sup>. The property is located in a zone with a maximum radon potential of less than 1%.

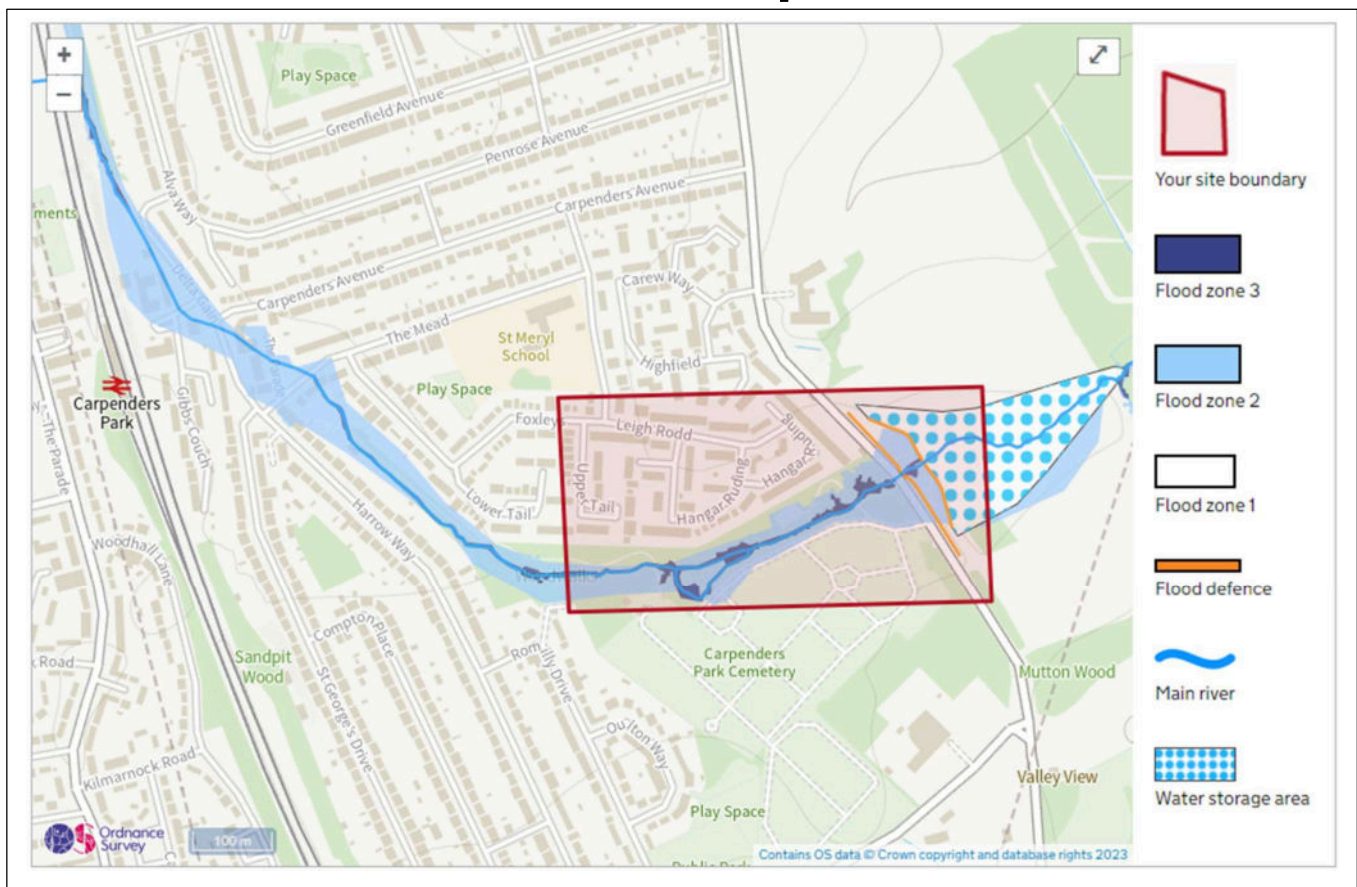
## Attachment 3 – Flood Map

A detailed investigation into the potential for flooding of the land on which the property lies has not been undertaken. However, we have consulted the website at <https://flood-map-for-planning.service.gov.uk/> built by the UK Government's Environment Agency and their information regarding the likelihood of flooding indicates that the WD19 5BH area is in flood zone 3 and is/not at risk from flooding.
